**High Ethanol Fuel Endurance:
A Study of the Effects of
Running Gasoline with 15%
Ethanol Concentration in
Current Production Outboard
Four-Stroke Engines and
Conventional Two-Stroke
Outboard Marine Engines**

David Hilbert
Mercury Marine
Fond du Lac, Wisconsin

Subcontract Report
NREL/SR-5400-52909
October 2011

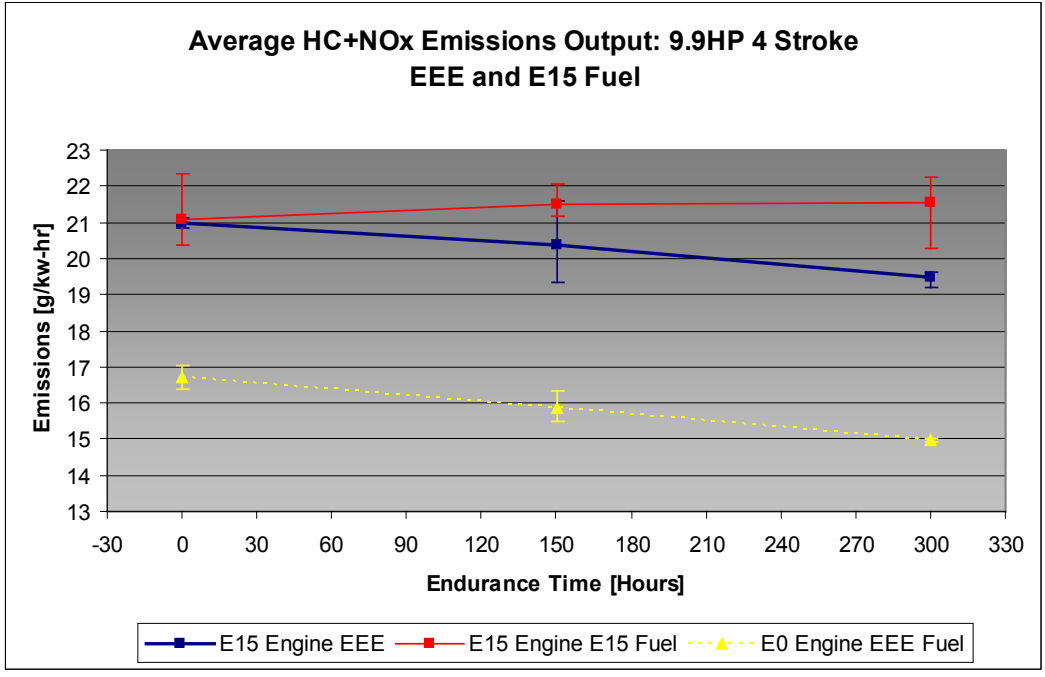
Figure 4: 9.9HP Four-Stroke HC+NOx Emissions Results Summary

the data from the E0 engine (serial number 0R364814). The solid red and blue lines show the emissions data from the E15 engine (serial number 0R352904) using E15 and E0 (EEE) fuels, respectively. Figure 4 shows that the E0 engine had significantly lower emissions than the E15 engine when run on the same fuel. After reviewing the history of the emissions audits on this engine family dating back to its introduction in 2005, both of these engines were within normal production variability.

Figures 5 and 6 show that the HC emissions predominantly defined the overall trends and variability in the total HC+NOx trends seen in Figure 4. The NOx data shown in Figure 6 had low test-to-test variability and the values were relatively flat (perhaps slightly declining for the E15 engine on E15 fuel) over the life of both engines.

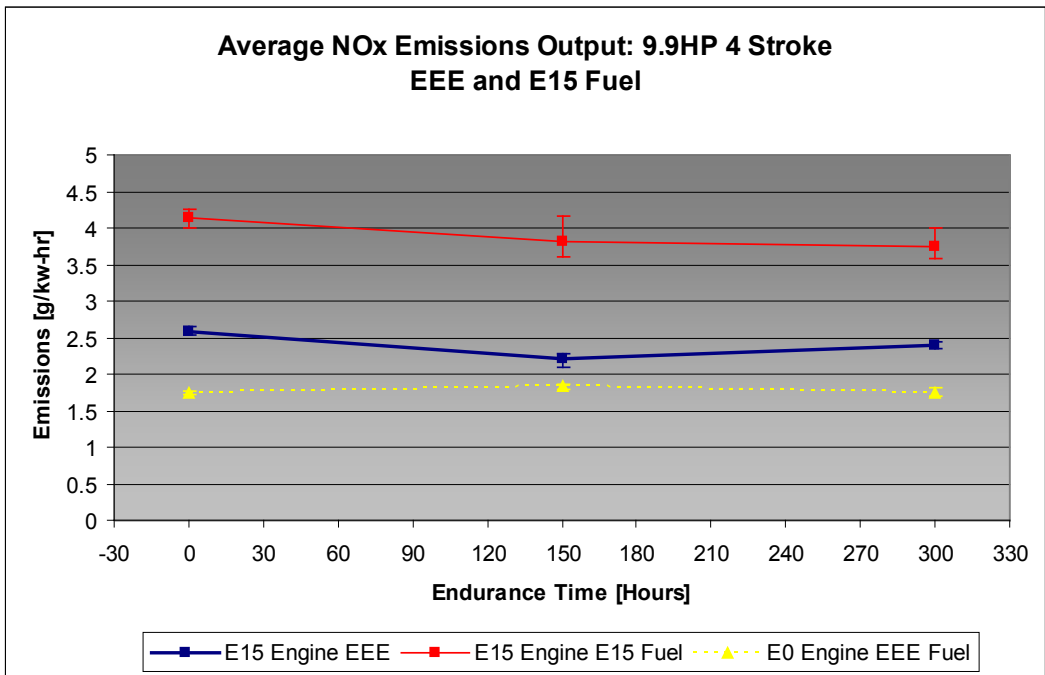
Figure 6: 9.9HP Four-Stroke NOx Emissions Results Summary

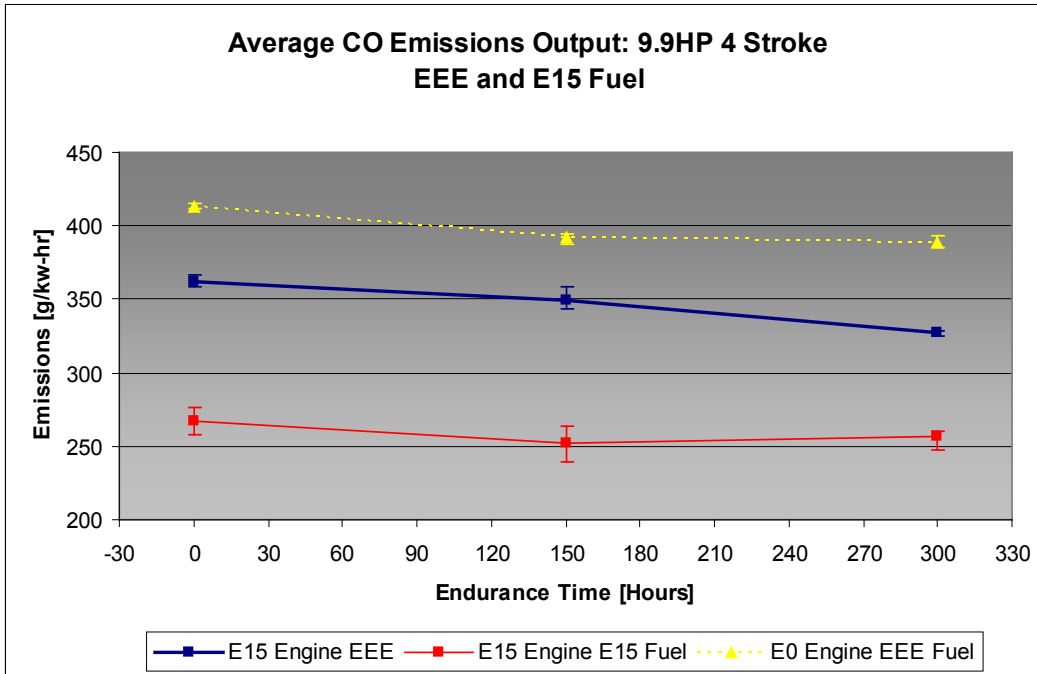
Figure 7: 9.9HP Four-Stroke CO Emissions Results Summary

There was a general downward trend in CO over endurance time for the E15 engine on both fuels. The E0 showed some reduction in CO between 0 and 150 hours and remained relatively flat from 150 to 300 hours. The reduction in CO would suggest that the engines were running leaner since the primary driver for changing the CO emissions is typically the equivalence ratio.

The enleanment over time trend predicted from the CO data in Figure 7 was confirmed in Figures 8 and 9 for both the E0 and E15 engines operated on EEE-E0 fuel in both cases. The interesting thing to note was that the primary modes that became leaner were modes 4 and 5. During the end of test inspection on both engines, wear on the throttle plates was found on the sides where the throttle shafts went through the carburetor bodies. The wear caused gaps around the throttle plates which allowed excess air to enter the engines at low throttle opening positions (high manifold vacuum), which included Modes 4 and 5. The amount of wear found was considered normal for the amount of endurance time the engines experienced and was found on both engines.

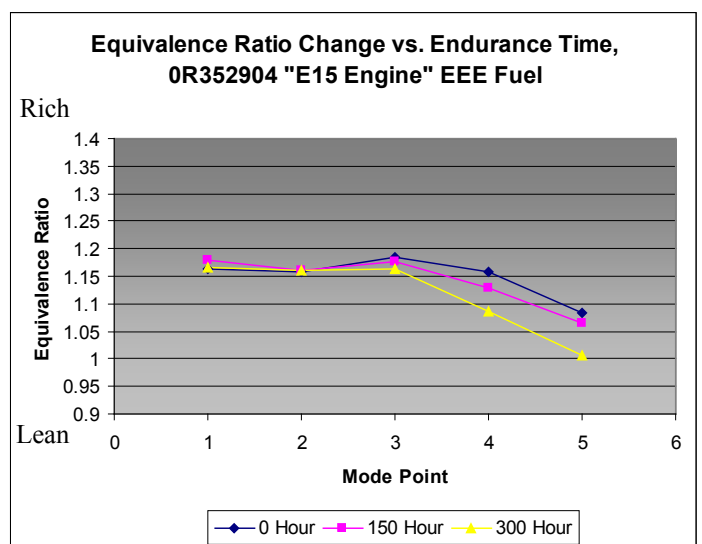
Figures 8 & 9: Change in Equivalence Ratio vs. Endurance Time-EEE Fuel on E0 engine and E15 Engine

It should be noted that the E15 engine ran leaner than the E0 engine when operated on EEE-E0 fuel, as can be seen in Figures 8 and 9 from a comparison of the "0 hour" equivalence ratios of both engines. This difference in equivalence ratio is considered to be in the normal production variability of this carbureted engine family.

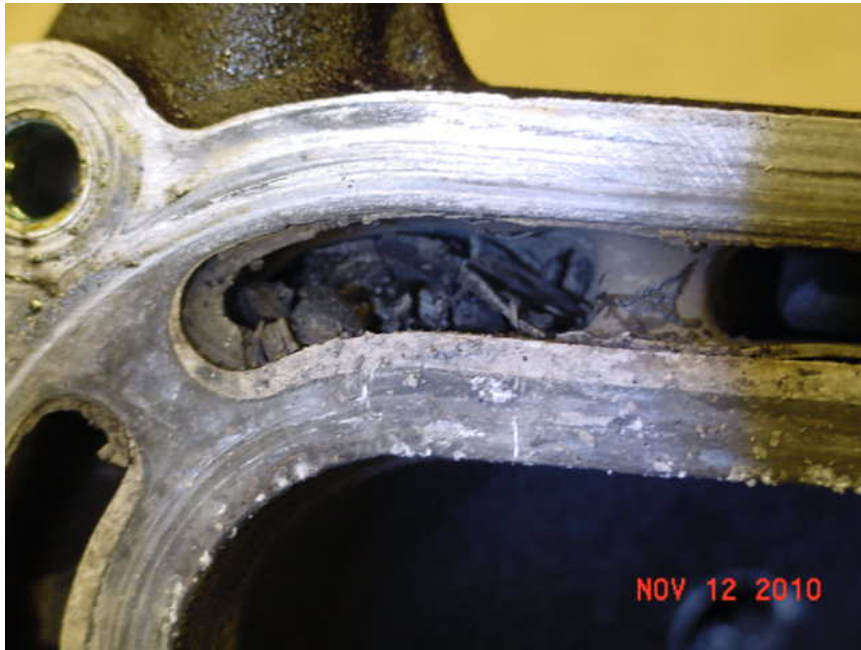
Figure 23: Mineral Deposits in Cooling Jacket, E0 Verado 1B812775A

E0 Engine #2-Test Facility-Induced Failure: An additional engine was obtained to replace the original E0 engine and this engine was given the serial number 1B821775A. This engine did the initial dyno tests and was put on endurance. After 88.7 hours of WOT endurance (98 total engine hours), the engine was automatically shut down by the endurance facility control system for low exhaust gas temperature. Investigation showed water entering the exhaust stream. The engine was then disassembled and a significant amount of mineral deposits were found in the cooling passages, especially in the exhaust collector on the cylinder head. See Figure 23. [Note: For a coolant fluid, outboard engines draw in water from the body of water they are operating in, which in this case was the endurance test tank.] An interaction between

the pH and hardness of the water in the test tank created conditions that precipitated out minerals (primarily calcite) when exposed to the elevated temperatures in the cooling passage, especially near the exhaust collector. The blocked passages prevented adequate cooling in the exhaust collector, which eventually failed the head gasket and allowed water to enter into the exhaust stream. See Figure 24. It should be noted that these water chemistry conditions were specifically caused by the test facility water conditioning and would not be something that the engine would experience in real-world use.

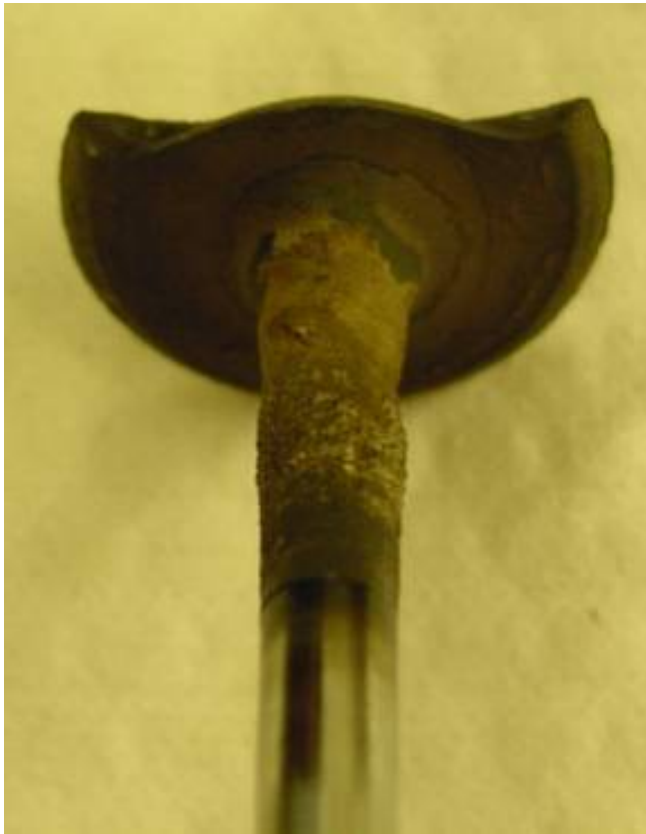
Figure 25: Broken Exhaust Valve from E15 Verado 1B812776, Top Valve in Cylinder 3

E15 Engine: At 285 hours of endurance operation (323 total engine hours), the E15 Verado test engine (serial number 1B812776) was noted to have rough idle after restarting shortly after maintenance was performed. A compression check was performed showing no compression on cylinder 3. During disassembly a broken exhaust valve was found in cylinder #3. Further investigation found that the other exhaust valve on cylinder 3 had developed a crack, as well as one

of the exhaust valves in cylinder 6. See Figures 25 and 26. NOTE: The images shown in Figure 26 of the cracked exhaust valves had been cleaned of deposits prior to photography.

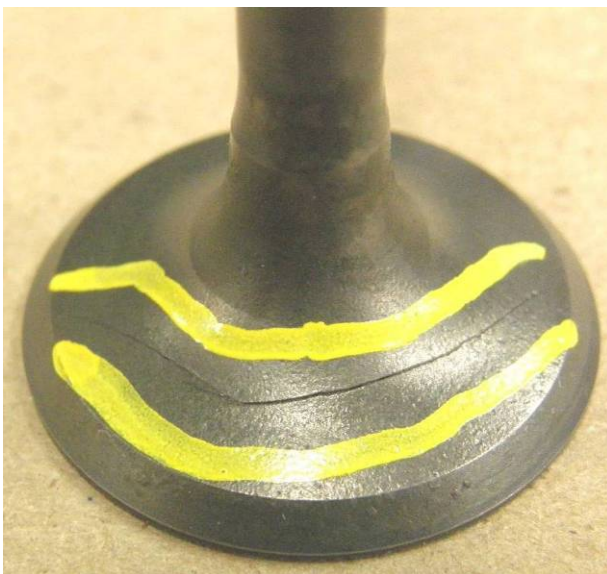
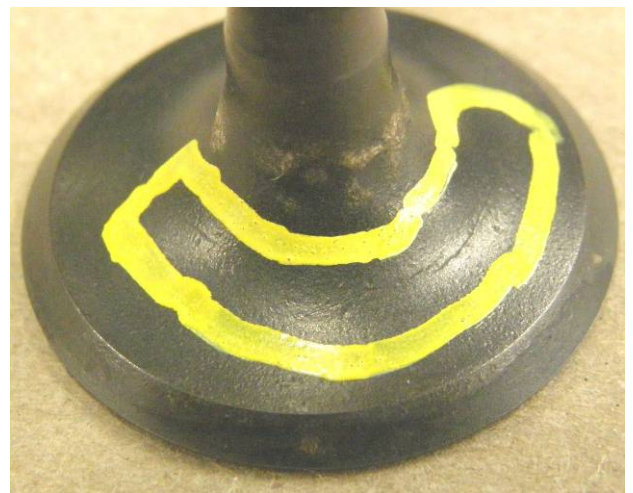
Figure 26: Cracked Valves from E15 Verado 1B812776, Bottom Valve in Cyl. 3 Left, and Top Valve in Cyl. 6 Right

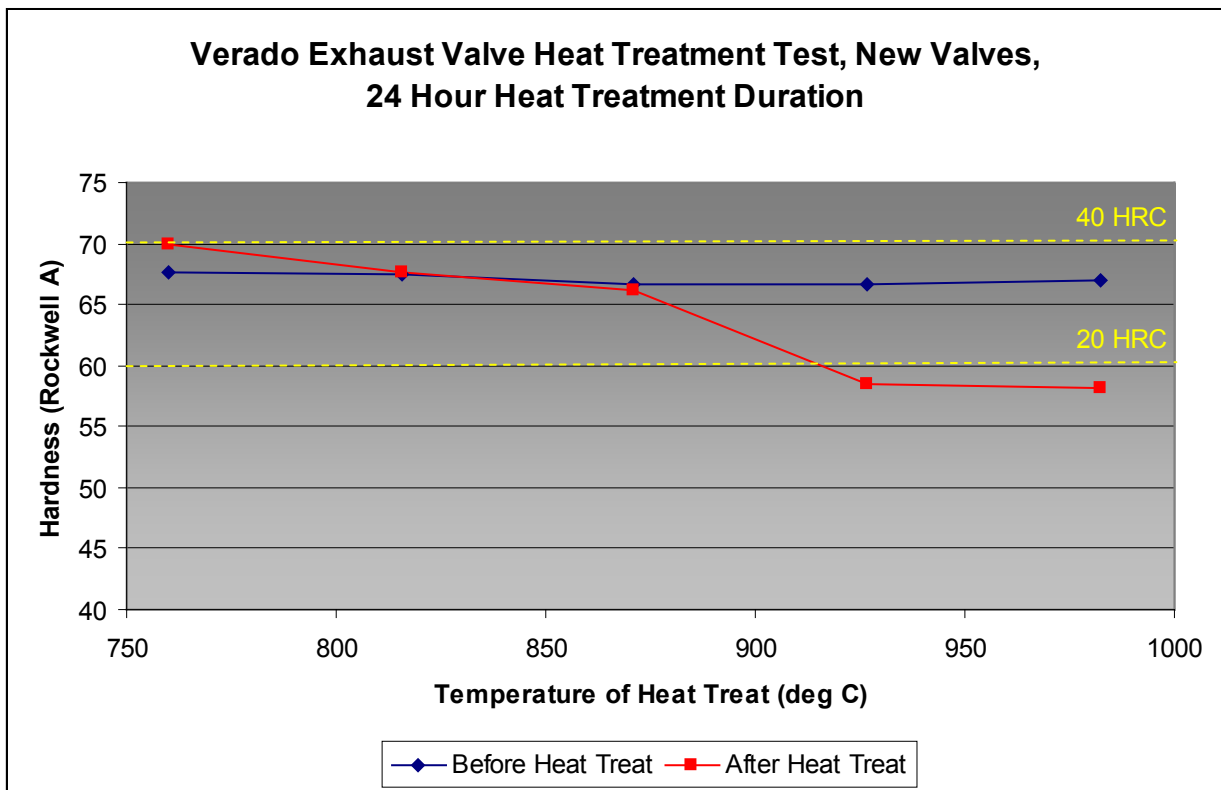
Figure 28: Heat Treatment Test of New Verado Valves

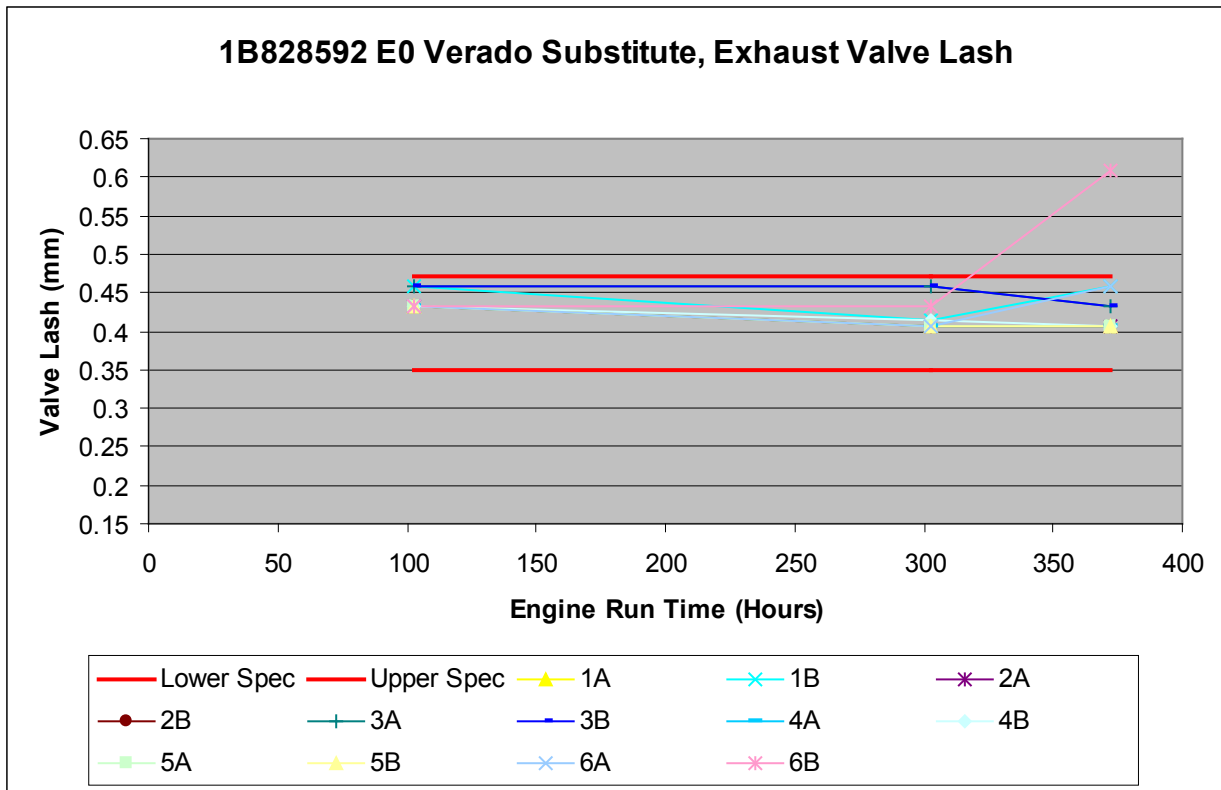
Figure 32: Exhaust Valve Lash (Measured Cold) vs. Endurance Time, E0 Substitute Engine

As part of routine maintenance and checks during endurance, several valve lash measurements were taken at various intervals on the E0 substitute engine. Figures 32 and 33 below show the lash measurements during the course of endurance for both the E0 substitute engine (1B828592) and the E15 engine (1B812776), respectively. The solid red lines in the graph indicate the upper and lower lash specification on a new engine. It is clear from the lash measurements on the 2 engines that the E15 engine had a significantly faster decline in lash than the E0 substitute engine. The E0 substitute engine had 1 valve with higher lash value at the end of testing. There may have been some carbon or other deposits holding this valve off the seat during the measurement.

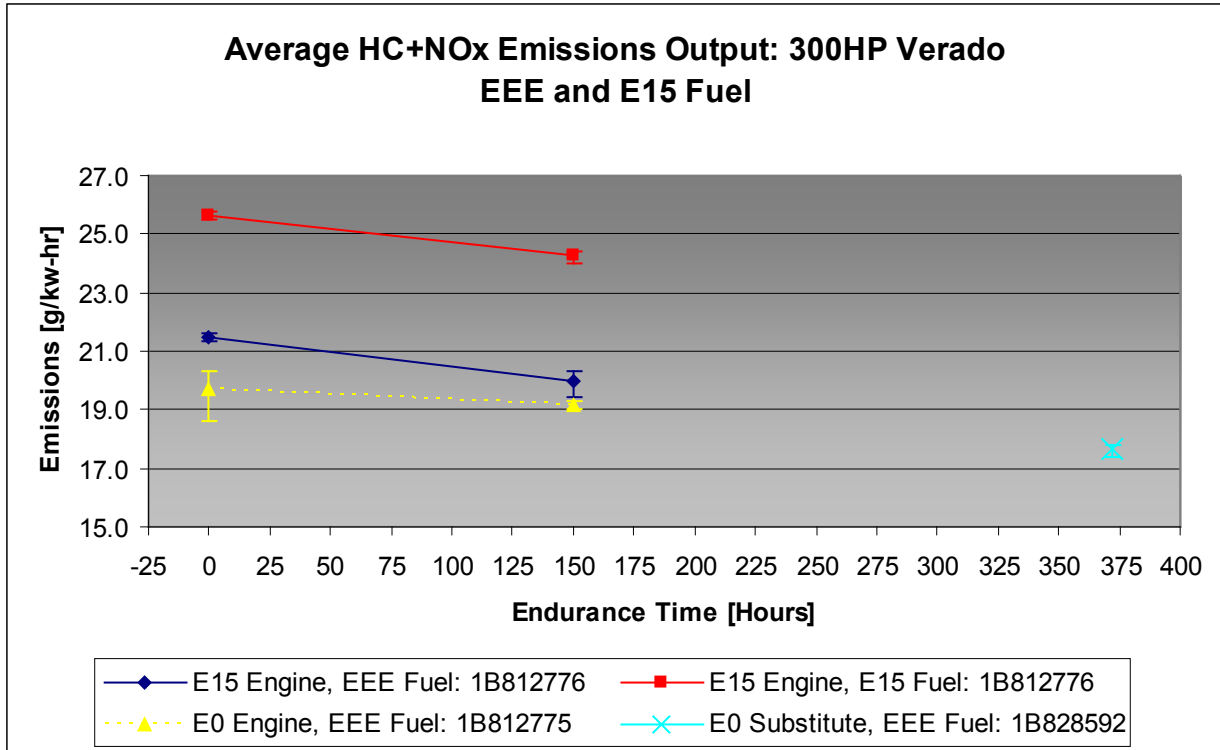
Figure 34: 300HP Verado HC+NOx Emissions Results Summary

Due to failures of both the E0 and E15 engines, a complete analysis of the deteriorated emissions was not possible. However, with the data available several conclusions could be made. Figure 34 shows a graph of the Verado emissions that were collected. As was the case for the 9.9HP emissions data plots, each data point on the curve represents the average emissions value of the 3 emissions tests performed at each interval with error bars showing the range of the 3 emissions tests. The dashed yellow line shows the data from the original E0 engine (serial number 1B812775). The solid red and blue lines show the emissions data from the E15 engine (serial number 1B812776) using E15 and E0 (EEE) fuels, respectively. The single point in light blue at 372 hours shows the end of test emissions results for the substitute E0 engine (EEE fuel, serial number 1B828592). The graph shows a generally declining HC+NOx trend for the 2 original engines which is typical of Verado engines. The declining emissions trends on both engines would suggest that the ethanol fuel blend did not adversely affect the emissions deterioration on the Verado engine. The most notable aspect of the emissions output on the E15 engine was the fact that the total HC+NOx on E15 fuel was above 25 g/kw-hr, whereas the value on EEE-E0 was 21.5 g/kw-hr. The Family Emissions Limit (FEL) was set to 22 g/kw-hr for this engine family. A Verado engine generating 25 g/kw-hr would have failed an emissions audit. The increase in emissions can be primarily attributed to a significant increase in NOx due to the lean operation. Since the Verado is a highly boosted engine it is very sensitive to NOx generation due to changes in equivalence ratio. However, there was also an increase in HC emissions due to the E15 fuel, which would not be expected with a leaner equivalence ratio.

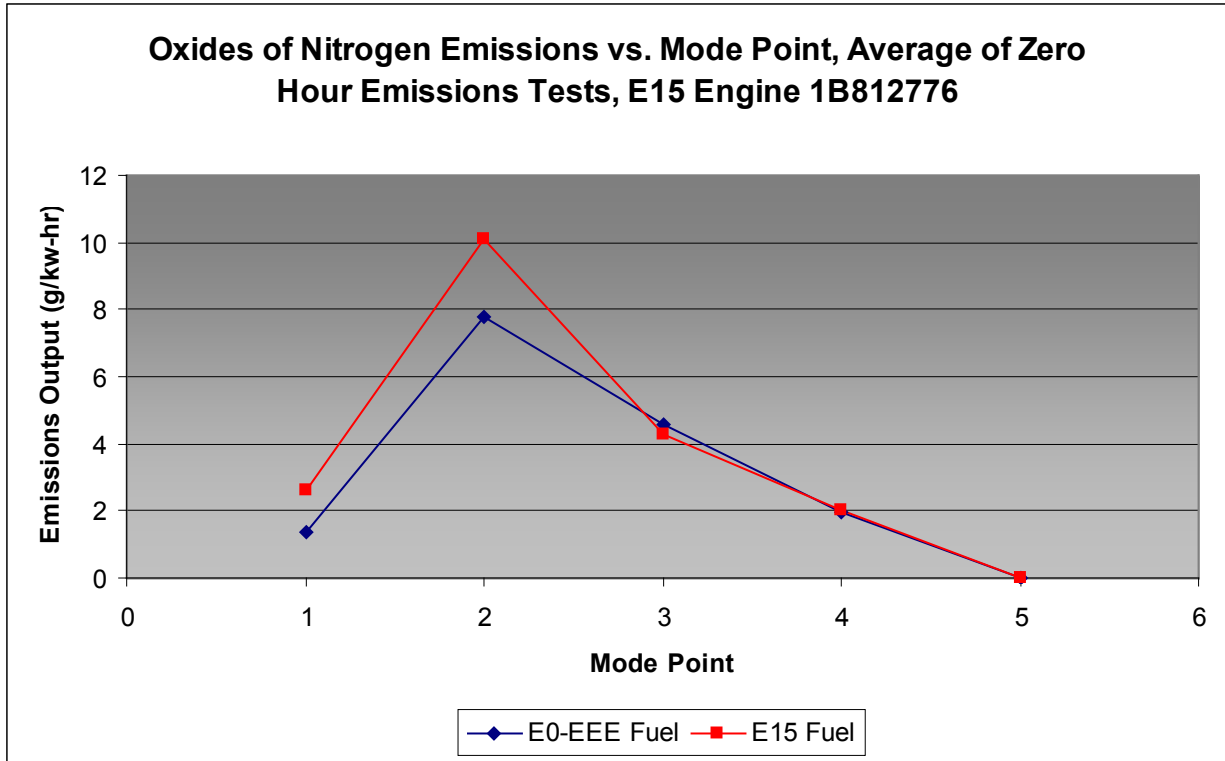
Figure 35: 300HP Verado NOx Emissions Results by Mode Point, Representative Zero Hour Test Data

Figure 35 shows the NOx emissions trends for the 2 fuels. The main differences were at Modes 1 and 2 which were both high load, boosted operating points. The fact that the NOx increased significantly with a lean shift due to the ethanol fuel blend was not surprising. Modes 3 and 4 did not show much difference because the engine was calibrated near an equivalence ratio of 1 on E0 fuel. The NOx trend with respect to equivalence ratio was near the peak at these points so a lean shift did not result in a significant change in NOx. Mode 5 was idle so the NOx generation at that point was essentially zero.

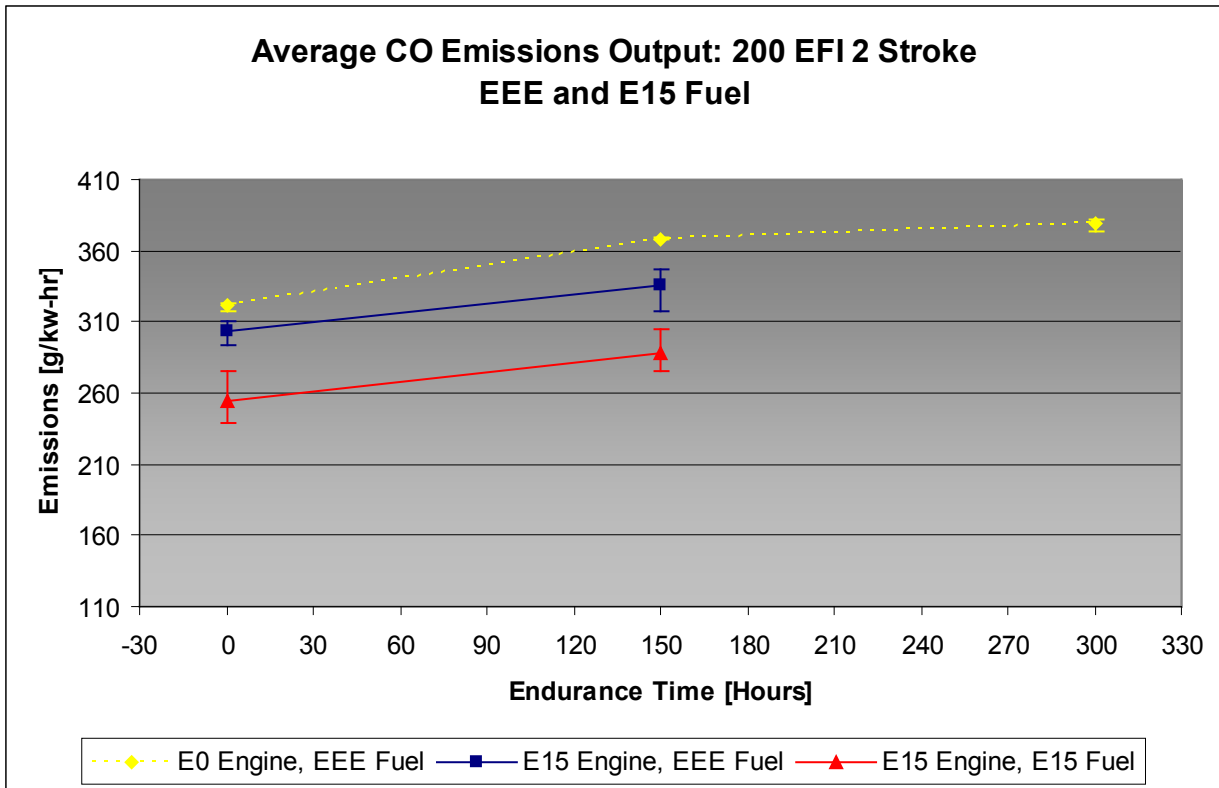
Figure 46: 200HP Two-Stroke CO Emission Results Summary

The CO emission results from the 200 EFI engines are shown in Figure 46. The E15 fuel resulted in lower CO emissions, as expected due to the relative enleanment from the difference in fuel chemistry. Both engines and both fuels showed the same trend of increasing CO with more endurance time.
